NASA
Technical Memorandum 106553

Prepared for the
18th Annual Meeting
sponsored by the Vibration Institute
Hershey, Pennsylvania, June 20-23, 1994

An Enhancement to the NA4 Gear Vibration Diagnostic Parameter

Harry J. Decker and Robert F. Handschuh
Vehicle Propulsion Directorate
U.S. Army Research Laboratory
Lewis Research Center
Cleveland, Ohio 44035

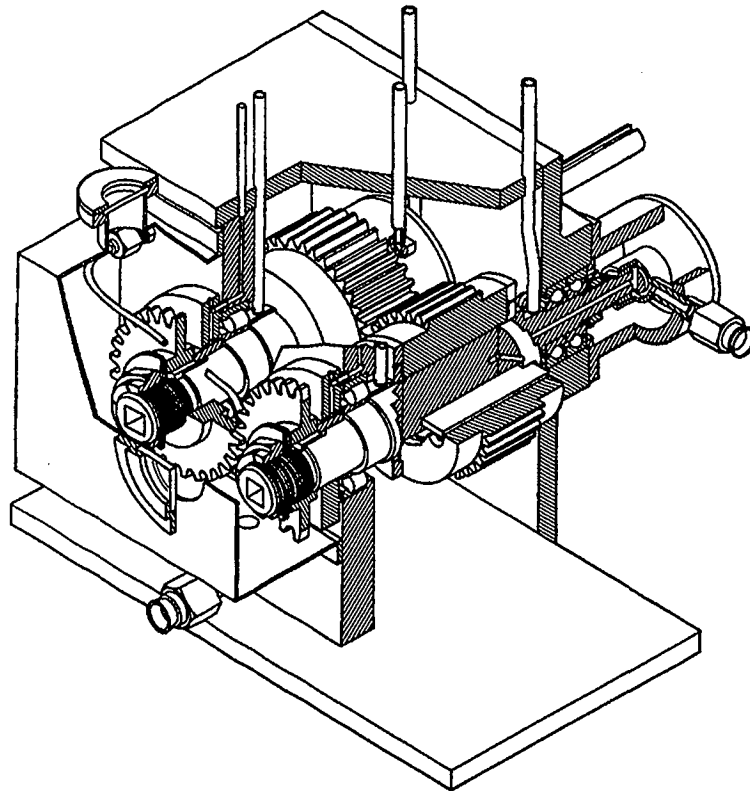
Figure 1.—Spur Gear Fatigue Rig.

The three parameters were tested using data obtained from gear fatigue test rigs at the NASA Lewis Research Center (figures 1 and 2). The purpose of these rigs is to study the effects of gear tooth design, gear materials and lubrication on the fatigue lives of aircraft quality gears. Vibration data from accelerometers mounted on each rig was captured with a personal computer using an analog to digital conversion board and an anti-aliasing filter. Both rigs use the closed loop torque regeneration principle. After the rigs are at operating conditions, the power system only has to supply enough power to overcome the losses in the system.

The spur gear test rig uses a pair of spur gears having 28 teeth, a pitch diameter of 88.9 mm

(3.50 in), and a face width of 6.35 mm (0.25 in). The gear faces are offset by 2.79 mm (0.11 in) to allow a higher surface stress without a corresponding increase in the bending stress. This, coupled with the ability to run on both sides of the profile, allows up to four fatigue failures per pair of gears. The pair transmits 143 kW (192 hp) as the gears rotate at 10,000 revolutions per minute.

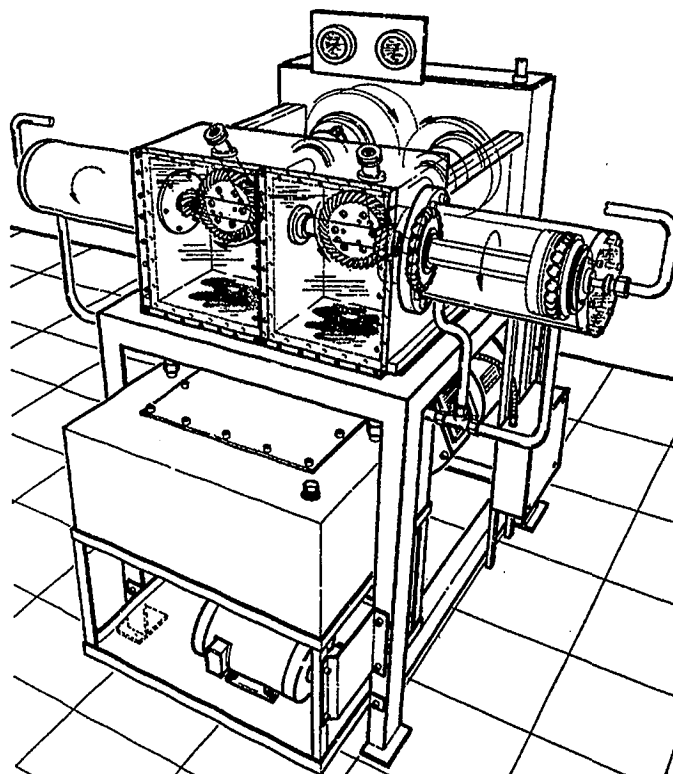
Figure 2.—Spiral Bevel Rig.

The spiral bevel gear test rig uses a 12 tooth test pinion and a 36 tooth gear both having a 35 degree spiral angle, a 25.4 mm (1 in) face width, 90 degree shaft angle, and a 22.5 degree pressure angle. The pair transmits 537 kW (720 hp) as the pinion rotates at 14,400 revolutions per minute.

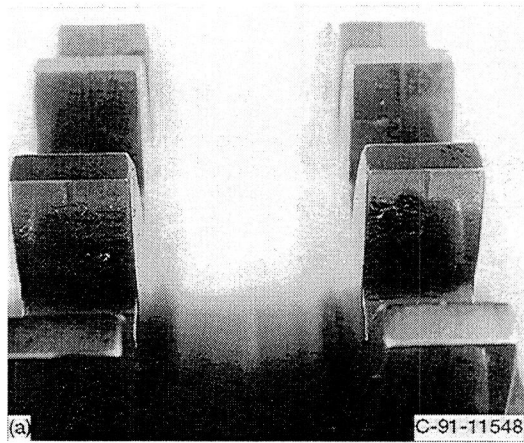
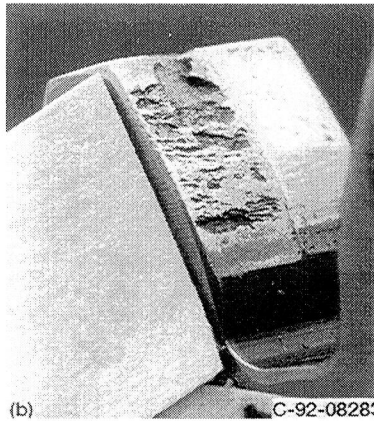
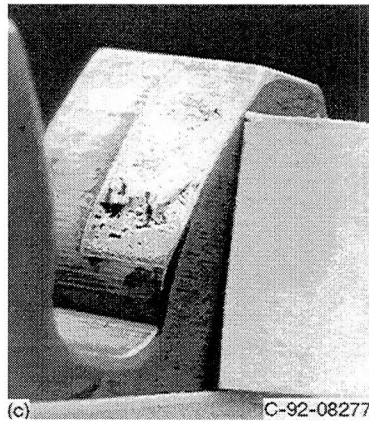
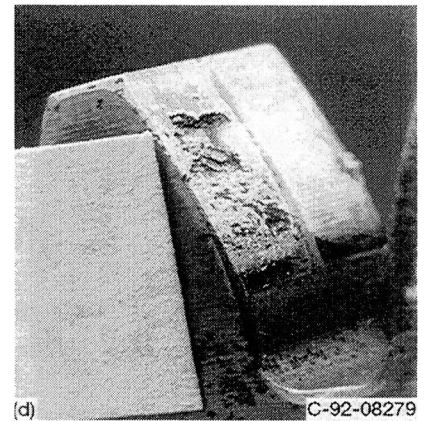
Figure 3.—(a) Heavy pitting on two teeth in Run 1 at 131 hr into run. (b) Example of spalling at end of Run 1. (c) Example of Run 2 moderate pitting. (d) Example of Run 3 heavy pitting.

At 131 hours into run 1, damage was found on two teeth on the driver gear (one heavy and one moderate pitting). Both mating teeth on the driven gear were also found to be damaged (both heavy pitting). Figure 3a illustrates the heavy pitting damage on the driver and driven gears at 131 hours. Figure 3b illustrates the spalling and heavy pitting damage found on roughly one third of the teeth on both the driver and driven gears at the end of the run.

At the end of run 2, damage was found on four consecutive teeth on the driver gear (one heavy and two moderate pitting). Two of the three mating teeth on the driven gear were also

found to be damaged (both moderate pitting). This damage is shown in figure 3c.

Figure 3d shows the damage that was found at the end of run 3. After 74 hours, four consecutive teeth on the driver gear had damage. One was spalled, with two teeth having heavy and one tooth having moderate pitting. One of the four mating teeth on the driven gear was also found to be damaged (moderate pitting).

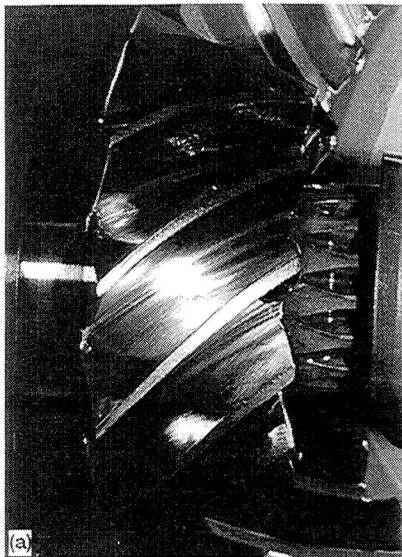
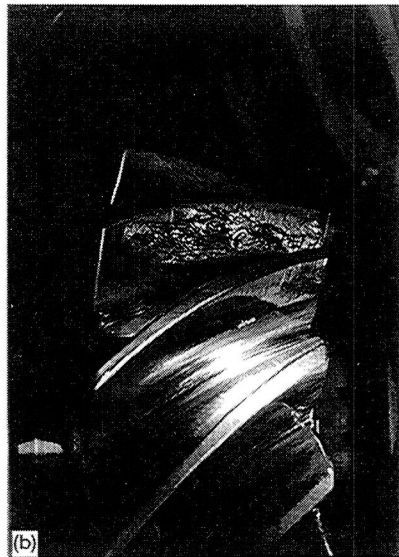
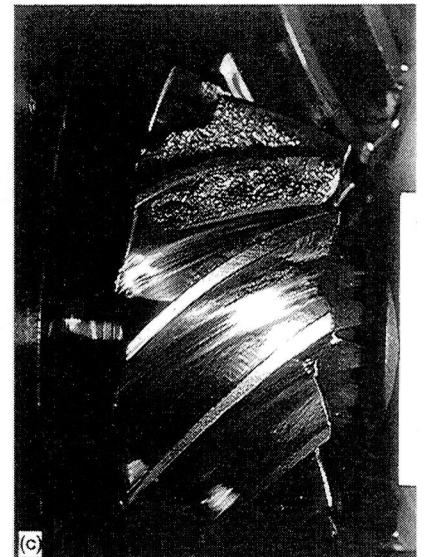
Figure 4.—Damage to Spiral Bevel pinion. (a) At 5.05 hr. (b) At 12.03 hr. (c) At end of run.

Data from one spiral bevel test were obtained. Pictures of tooth damage on the pinion at various stages in the test are illustrated in figures 4a, 4b, and 4c. The rig was shut down a total of eight times to observe and document the damage as it progressed during the run. Only the results of three of these shutdowns will be discussed. At the first shutdown, at about five and one half hours into the test, a small pit was observed on one of the teeth on the test pinion as illustrated in figure 4a. At approximately twelve hours into the run, pitting started to appear on adjacent teeth, as seen in figure 4b. The pitting on the adjacent teeth continued to grow until it covered a majority of the face of three adjacent teeth on the pinion, and part of the face of another adjacent tooth. The run was stopped when one of the three heavily pitted pinion teeth was found to have fractured, losing one-third of the tooth, as illustrated in figure 4c. The fracture occurred between 16.16 and 17.79 hours into the test.

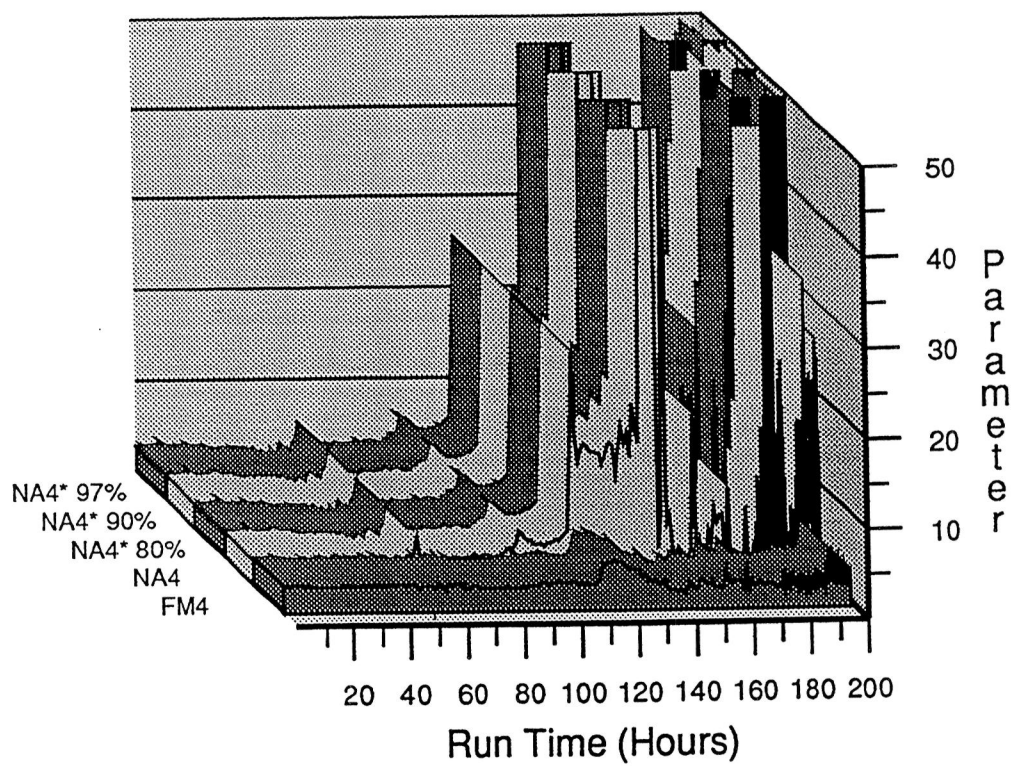
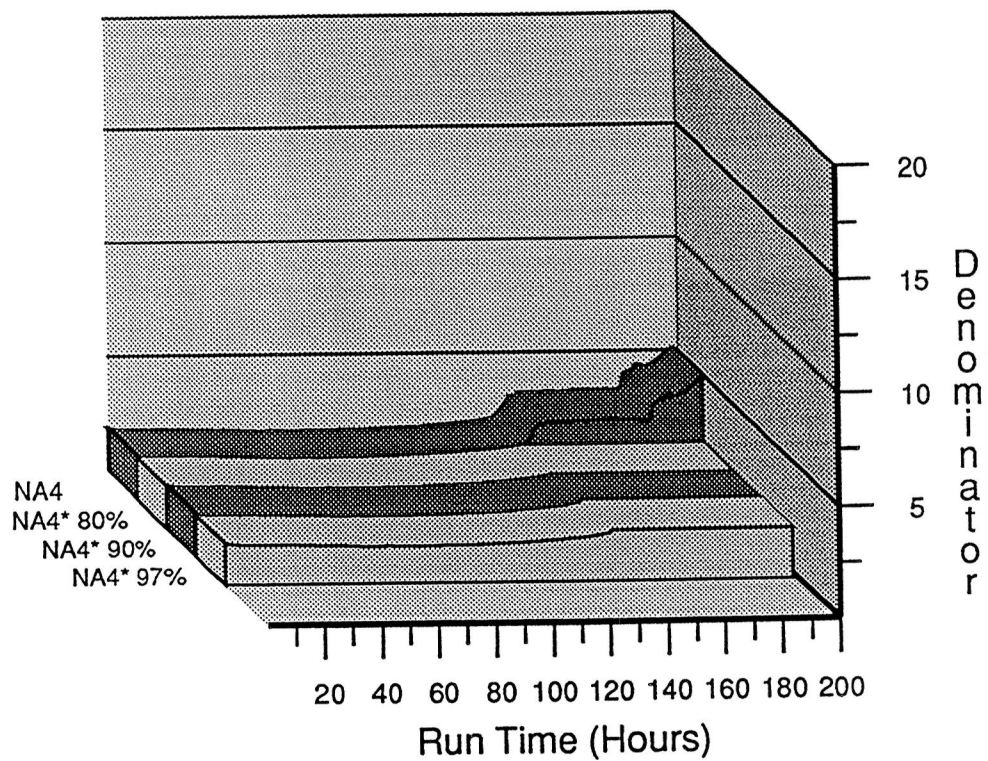
Figure 5.—Parameters for Spur Gear Run 1.

The comparisons between FM4, NA4 and a version of NA4* for test runs 1, 2, and 3 are shown in figures 5, 6, and 7, respectively. Due to limitations in the testing procedure, it is difficult and time consuming to correlate the actual condition of the gears with the vibration parameters that are calculated. Experience determines what an appropriate value for facility shutdown should be. At that time, if significant damage is present, the test is suspended, otherwise the test is restarted.

At 131 hours into test 1, the value of the NA4 parameter was very high, the rig was shut down, the gears removed, inspected and photographed. The gears were then re-installed and the test continued. From figure 5, it is assumed that a large amount of damage occurred around 112 hours into the test. NA4 and NA4* both react well to the damage by increasing to a value of 25 and only reducing to a value of 15 as localized damage progressed. FM4, however, peaked to a value of 5.4, then produced a Type I error when it dropped to its nominal value around 3. It is interesting to note that the NA4* parameter does not come

back down to the NA4 level and that the shapes of the curves are nearly identical. This implies that the irregularities of the curve is a function of just the numerator and not both the numerator and denominator. The drastic irregularities that occur after 170 hours are unique to this test and have not been observed in any other test.

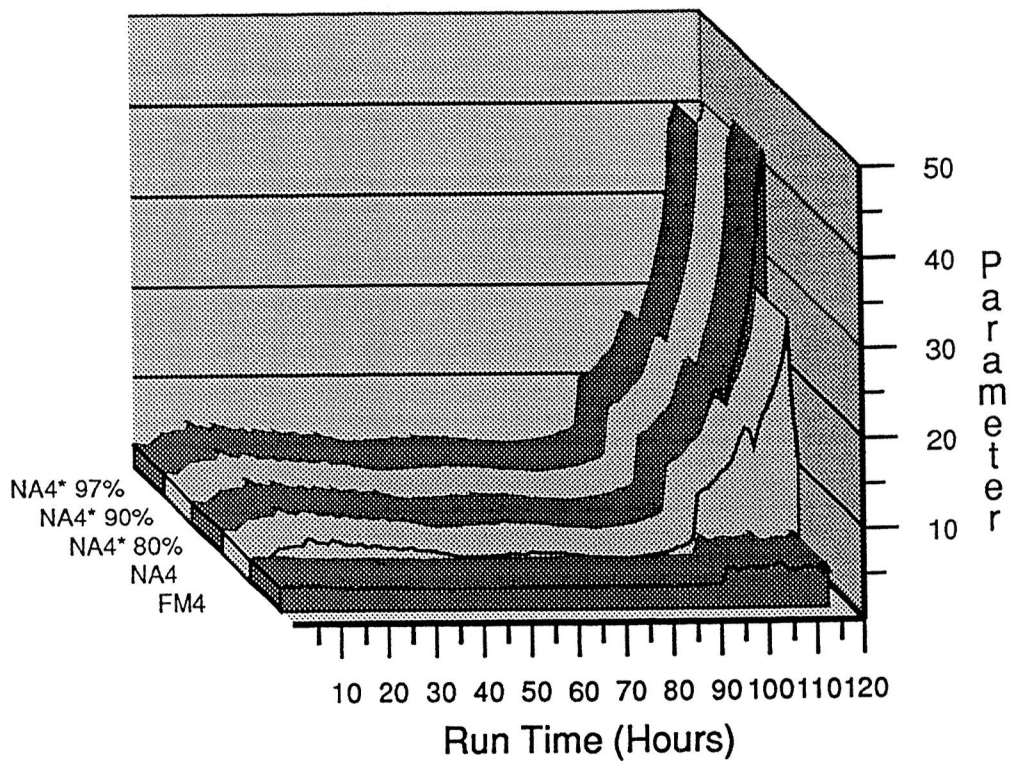
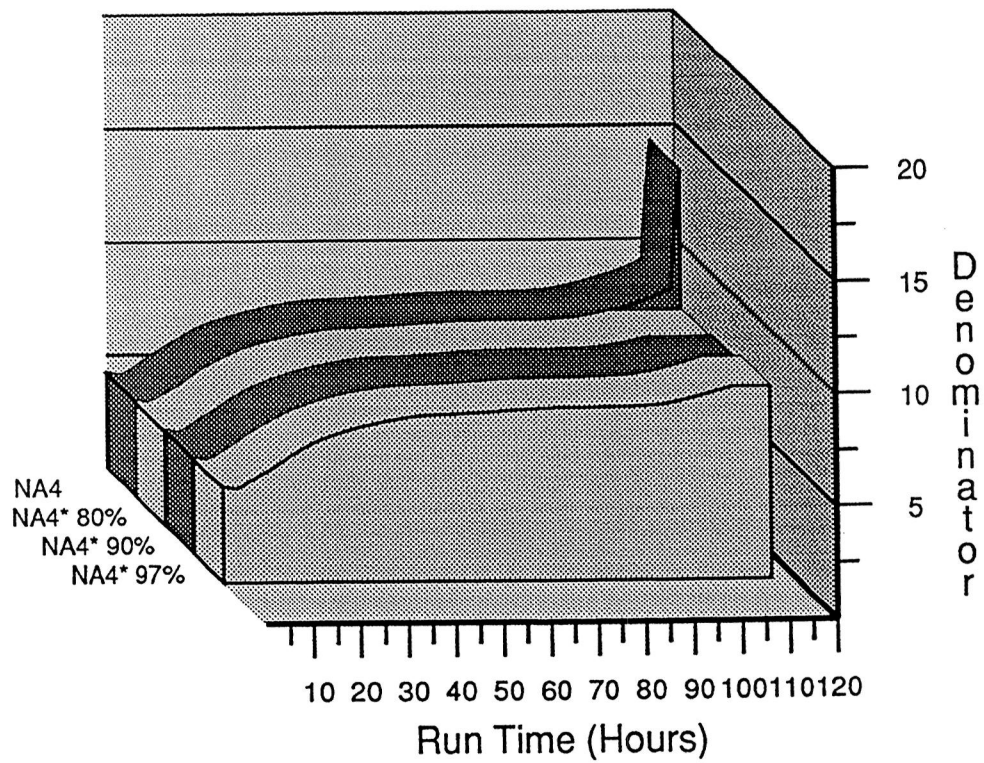
Figure 6.—Parameters for Spur Gear Run 2.

The results from run 2 (figure 6) give the best example of the desired effect of using NA4* versus NA4. The most striking attributes of the curves are the difference in magnitudes and that the NA4* parameter did not give a Type I error. Again, notice that the overall shape of the curve is primarily a function of the numerator. It is interesting to note that the NA4 and FM4 parameters react at the same point in time, although with different sensitivities.

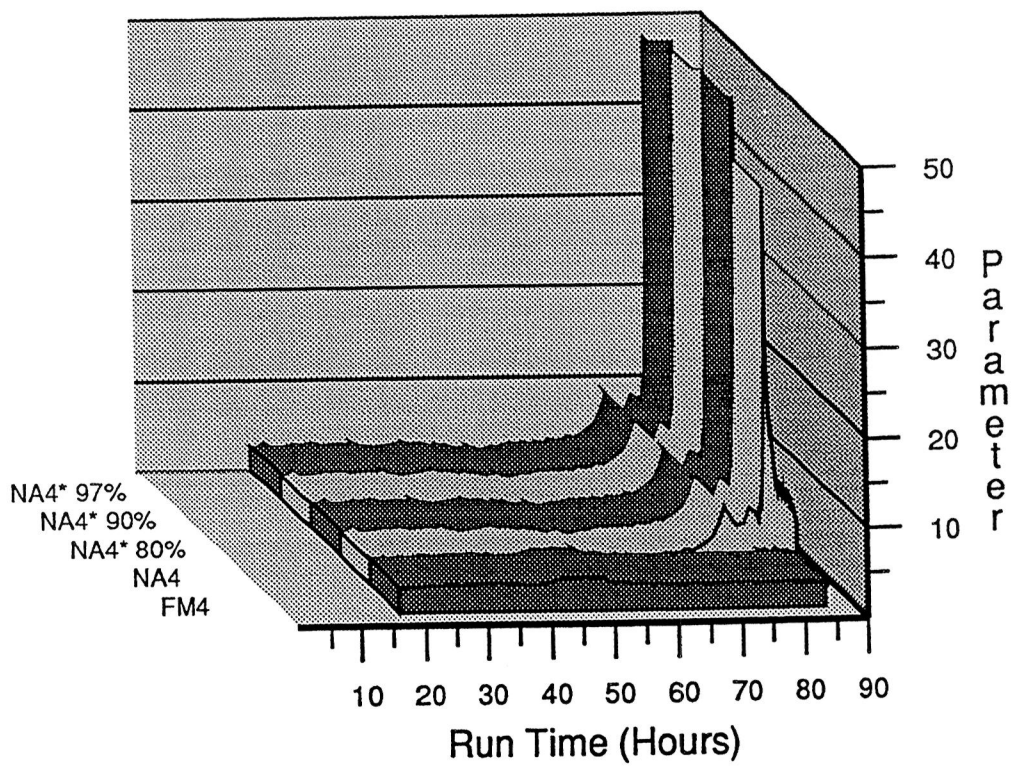
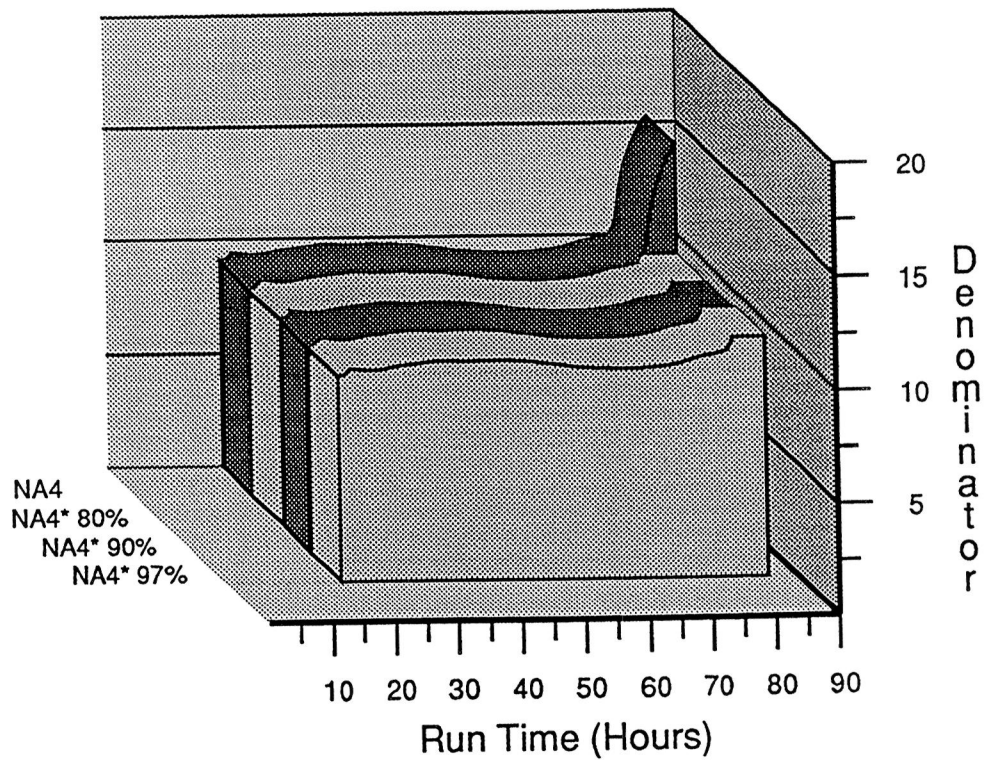
Figure 7.—Parameters for Spur Gear Run 3.

The results from run 3 (figure 7) show the same effect, although not as drastically. The important characteristic to note is that the NA4* parameter is most robust at indicating damage for both the initiation of damage as well as when damage progresses. On the other hand, the FM4 and NA4 parameters may return to levels indicating no damage when actually localized damage is progressing. As with the other runs, FM4 still shows the damage occurring, but it is more susceptible to misinterpretation than NA4 and NA4*.

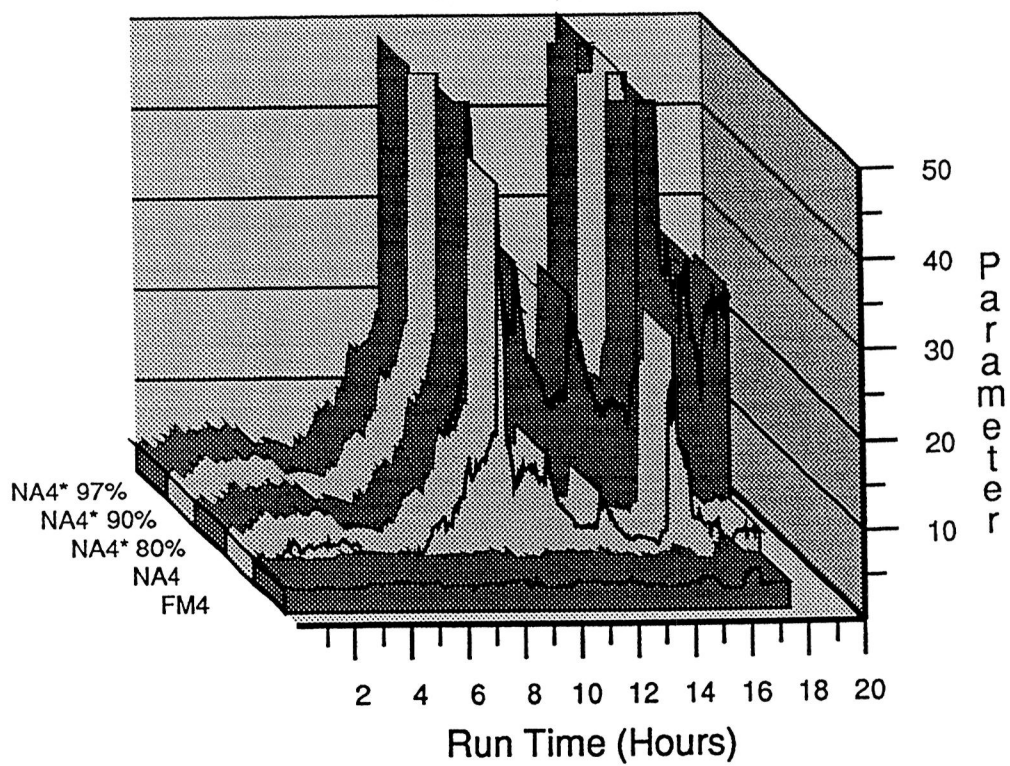
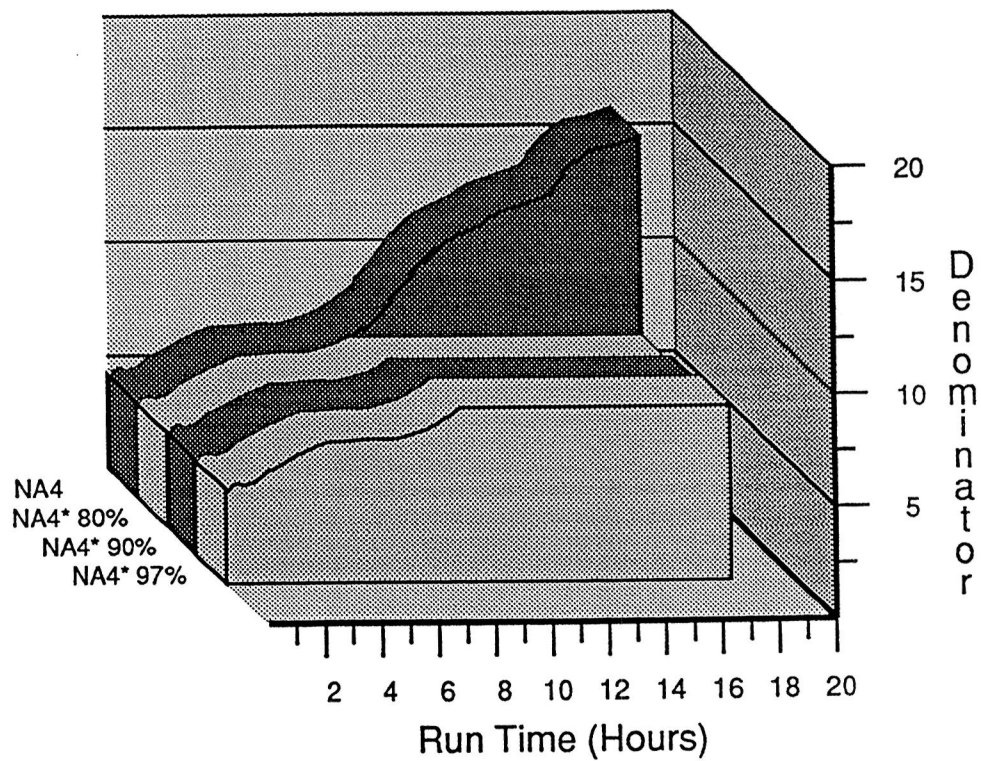
Figure 8.—Parameters for Spiral Bevel Run.

In the results of the spiral bevel test (figure 8), the FM4 parameter did not respond well, only hinting at some damage at about 16 hours. This was well after severe pitting and spalling was documented. For most of the run FM4 was producing a Type I error. The NA4 and NA4* curves give an early and robust indication that damage has occurred. In figure 8, the

effect of using different confidence intervals is best illustrated. In fact, it is suspected that damage started about 1.5 hours into the test when the NA4 and NA4* parameters have a value of near 5 for about 2 hours.

There were some differences in the versions of NA4* corresponding to the selected coefficients. Although a confidence coefficient of 80% is suggested, more experience is needed to determine which produces the best result.
